**Report: Chilt/RF11067**

**A fire resistance test performed on  
eighteen pipe penetration sealing  
systems within a flexible supporting  
construction**

**Test conducted in accordance with  
BSEN 1366-3: 2009  
Test date: 11<sup>th</sup> May 2011**

**Prepared for: Tenmat Ltd  
Ashburton Road West  
Trafford Park  
Manchester  
M17 1RU**

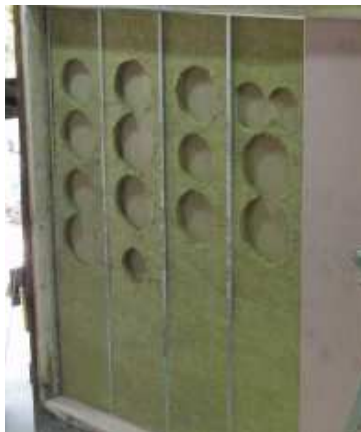
The mineral wool insulation was removed for 100mm surrounding the cut out apertures (see below).

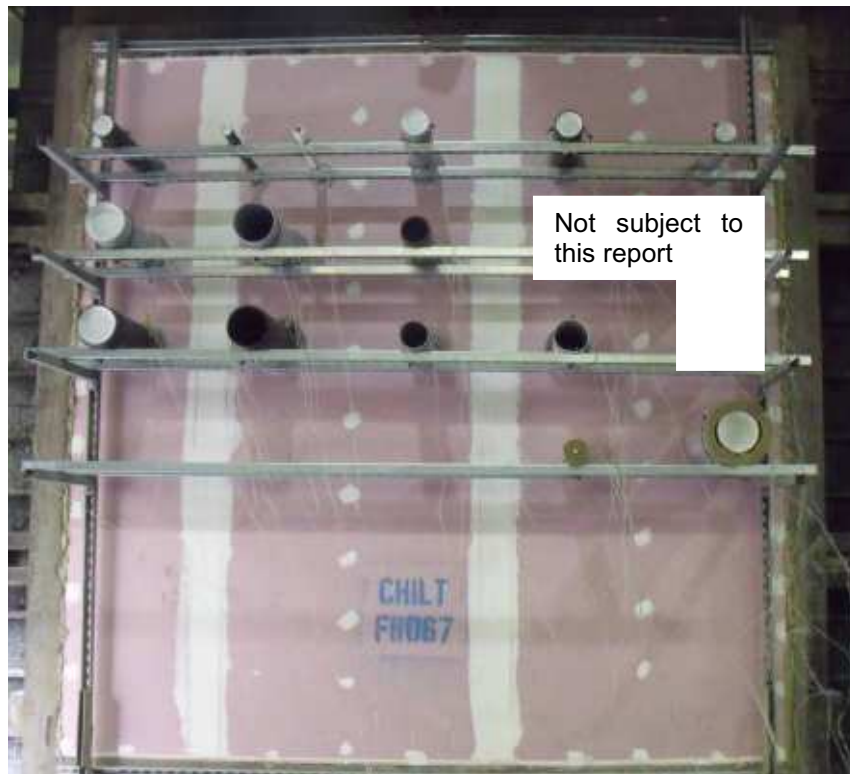
##### Unexposed face supporting construction

On the exposed face, 2No 3000mm Unistrut sections were used as vertical supports, bracketed to 2No. Unistrut sections fixed at the top and bottom of the restraint frame. 8No 500mm long Unistrut cantilever arm sections provided support for Unistrut ‘U’ section channels supporting the pipes at 150mm and 450mm from the wall. All specimens were fixed to the supporting Unistrut ‘U’ section channels using cable ties.

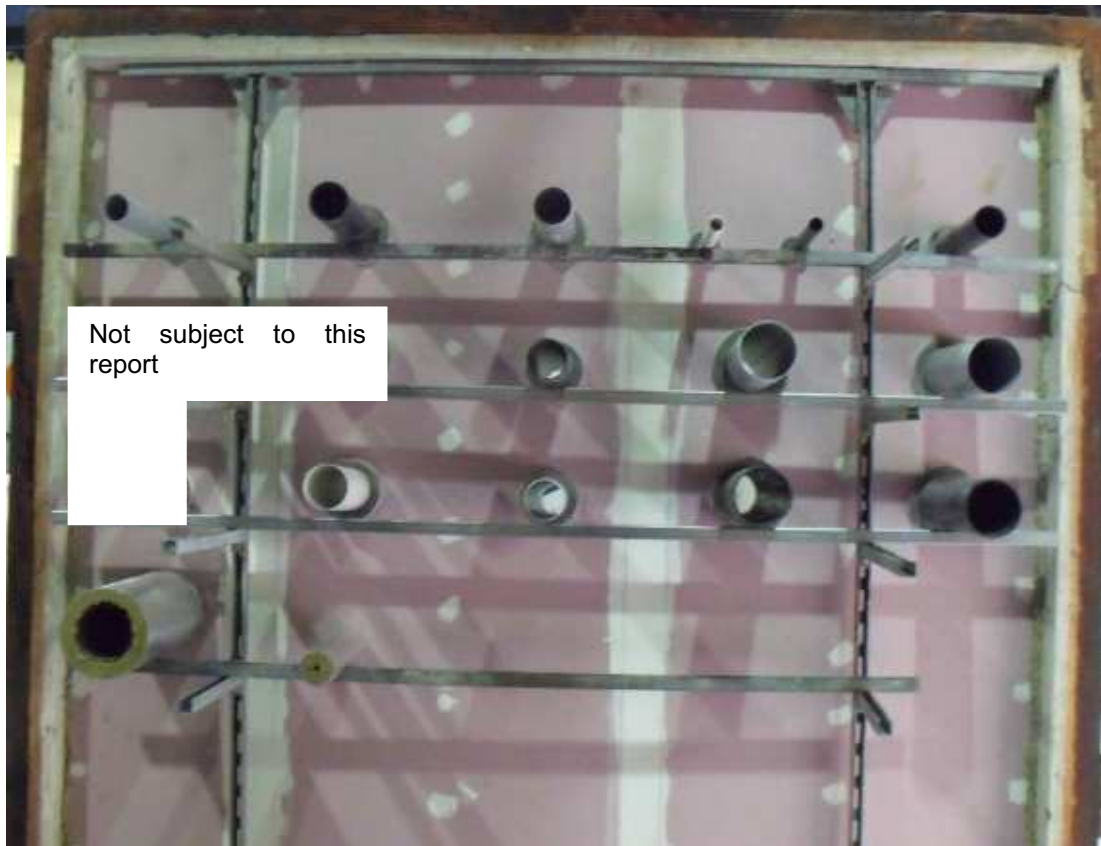
## Exposed face support system

On the exposed face, 2No 3000mm Unistrut sections were used as vertical supports, bracketed to 2No. Unistrut sections fixed at the top and bottom of the restraint frame. 8No 500mm long Unistrut cantilever arm sections provided support for 8No horizontal lengths of Unistrut, supporting the pipes at 300mm from the wall.

All pipes were not fixed to the supports.

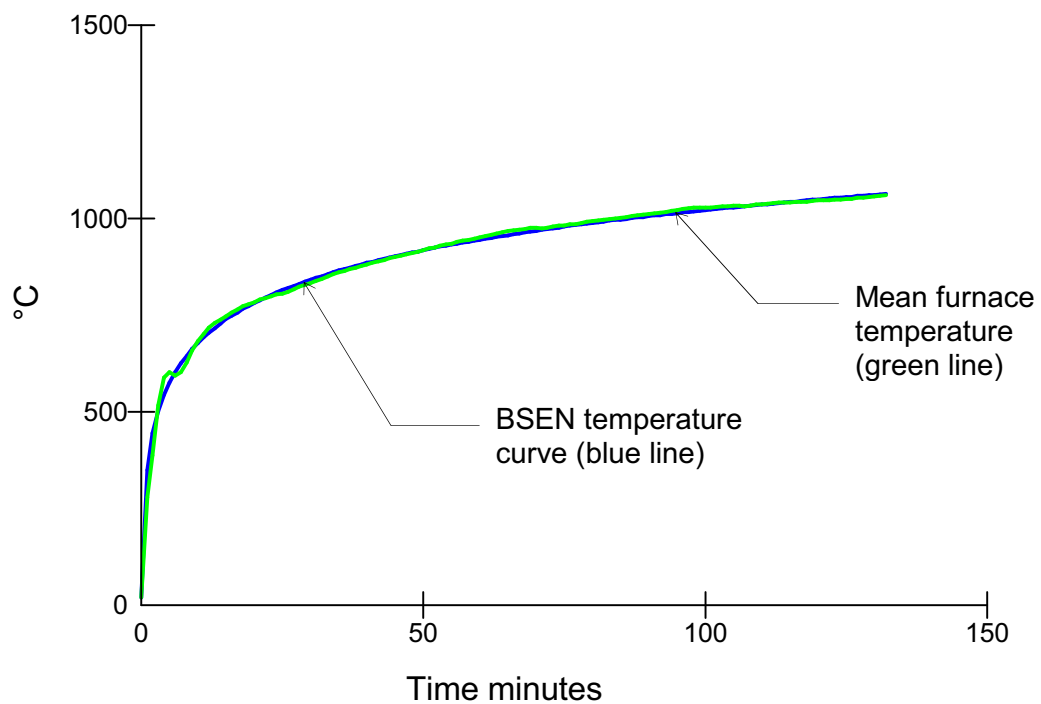
The furnace was controlled to follow the temperature/time relationship specified in BSEN 1363: Part 1: 1999 Section 5.1.1 as closely as possible, using the average of nine plate thermometers suitably distributed within the furnace. The temperatures recorded have been tabulated in Appendix 2 and are shown graphically below:

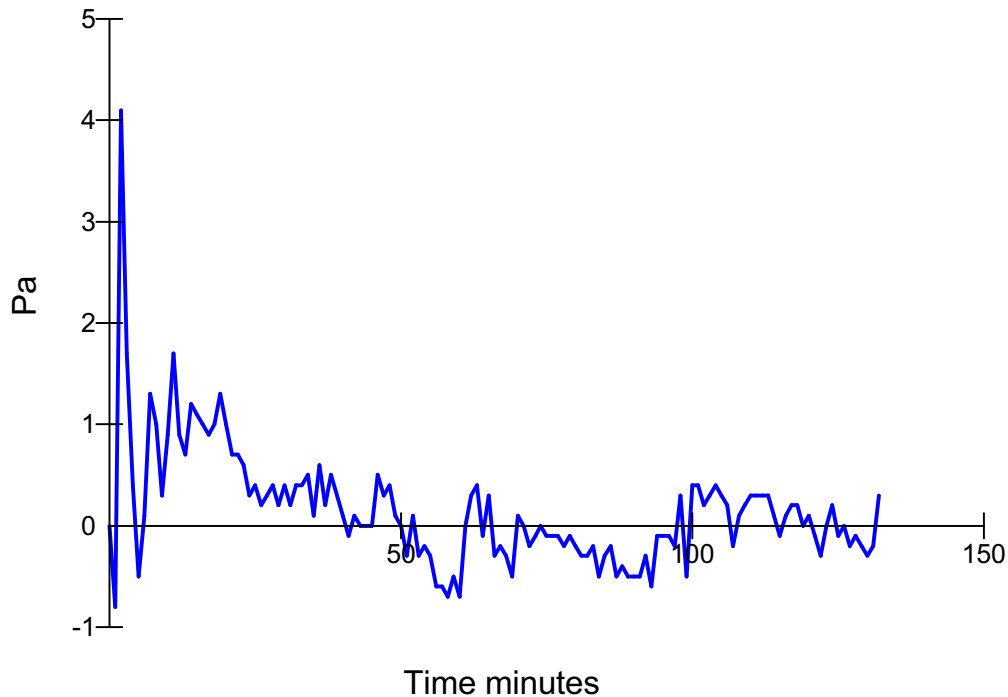
After the first 5 minutes of the test, the furnace pressure was maintained at  $0.5 \pm 5$  Pa and after 10 minutes was maintained at  $0.5 \pm 3$  Pa with respect to atmosphere, at a point 0.5m from the notional floor level. Therefore equating to 10 Pa at the base of penetration seals 12, 13, 14, 15 and 16. The pressure readings have been tabulated in Appendix 2 and are shown graphically below:

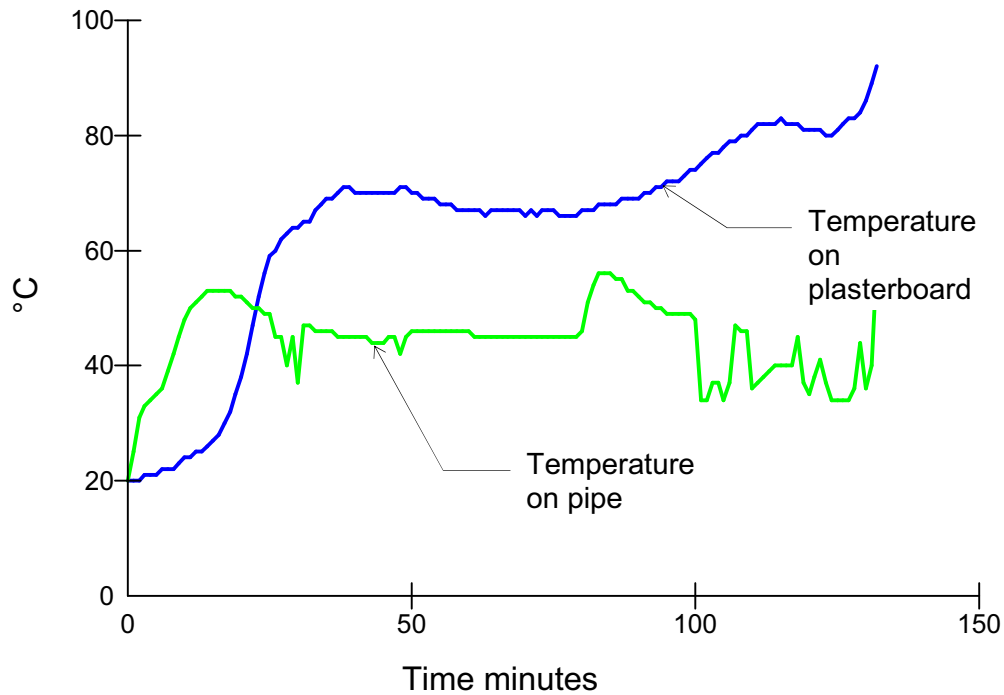
#### Pipe 1

### Unexposed face temperature curves

Graphs of each service penetration can be found in Section 10.  
The temperatures recorded have been tabulated in the Appendix 2.

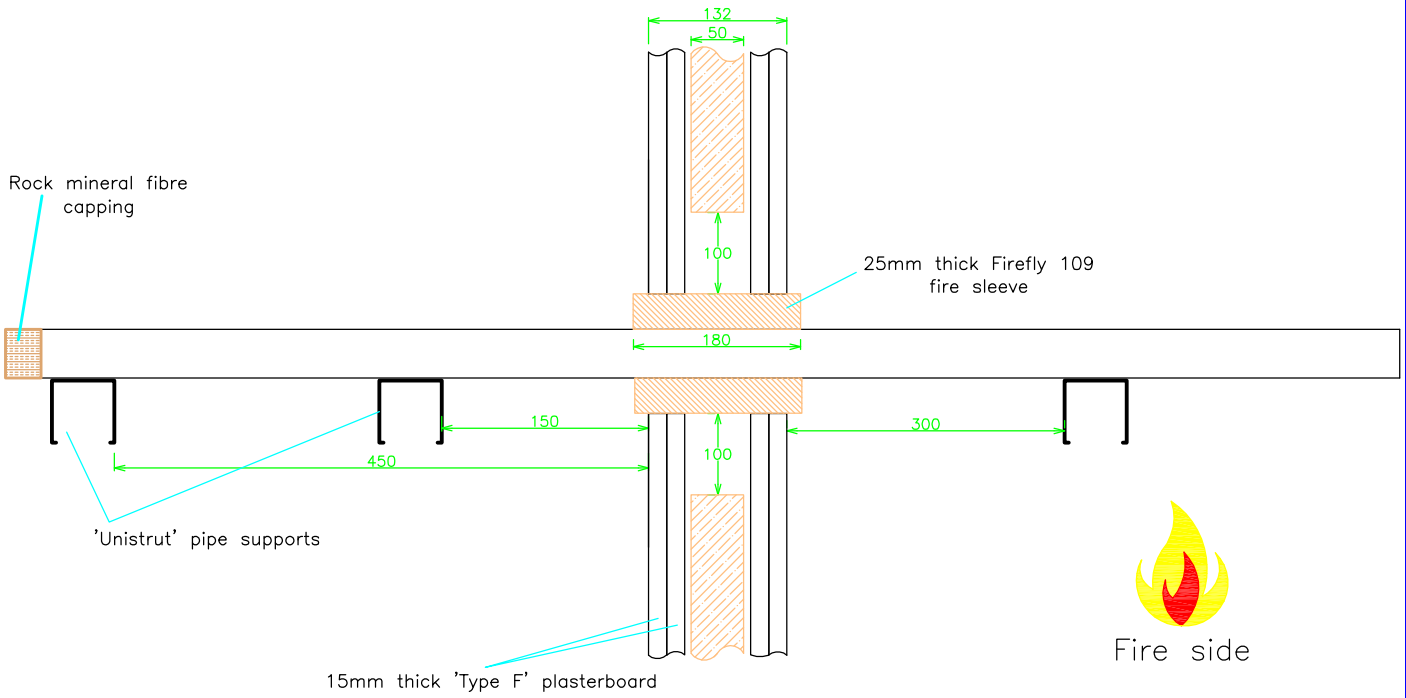
Pipe sealing system  
pipes 1 to 7 and 12

Title Cross section of pipe seals  
1 to 7, 12, 17 and 18

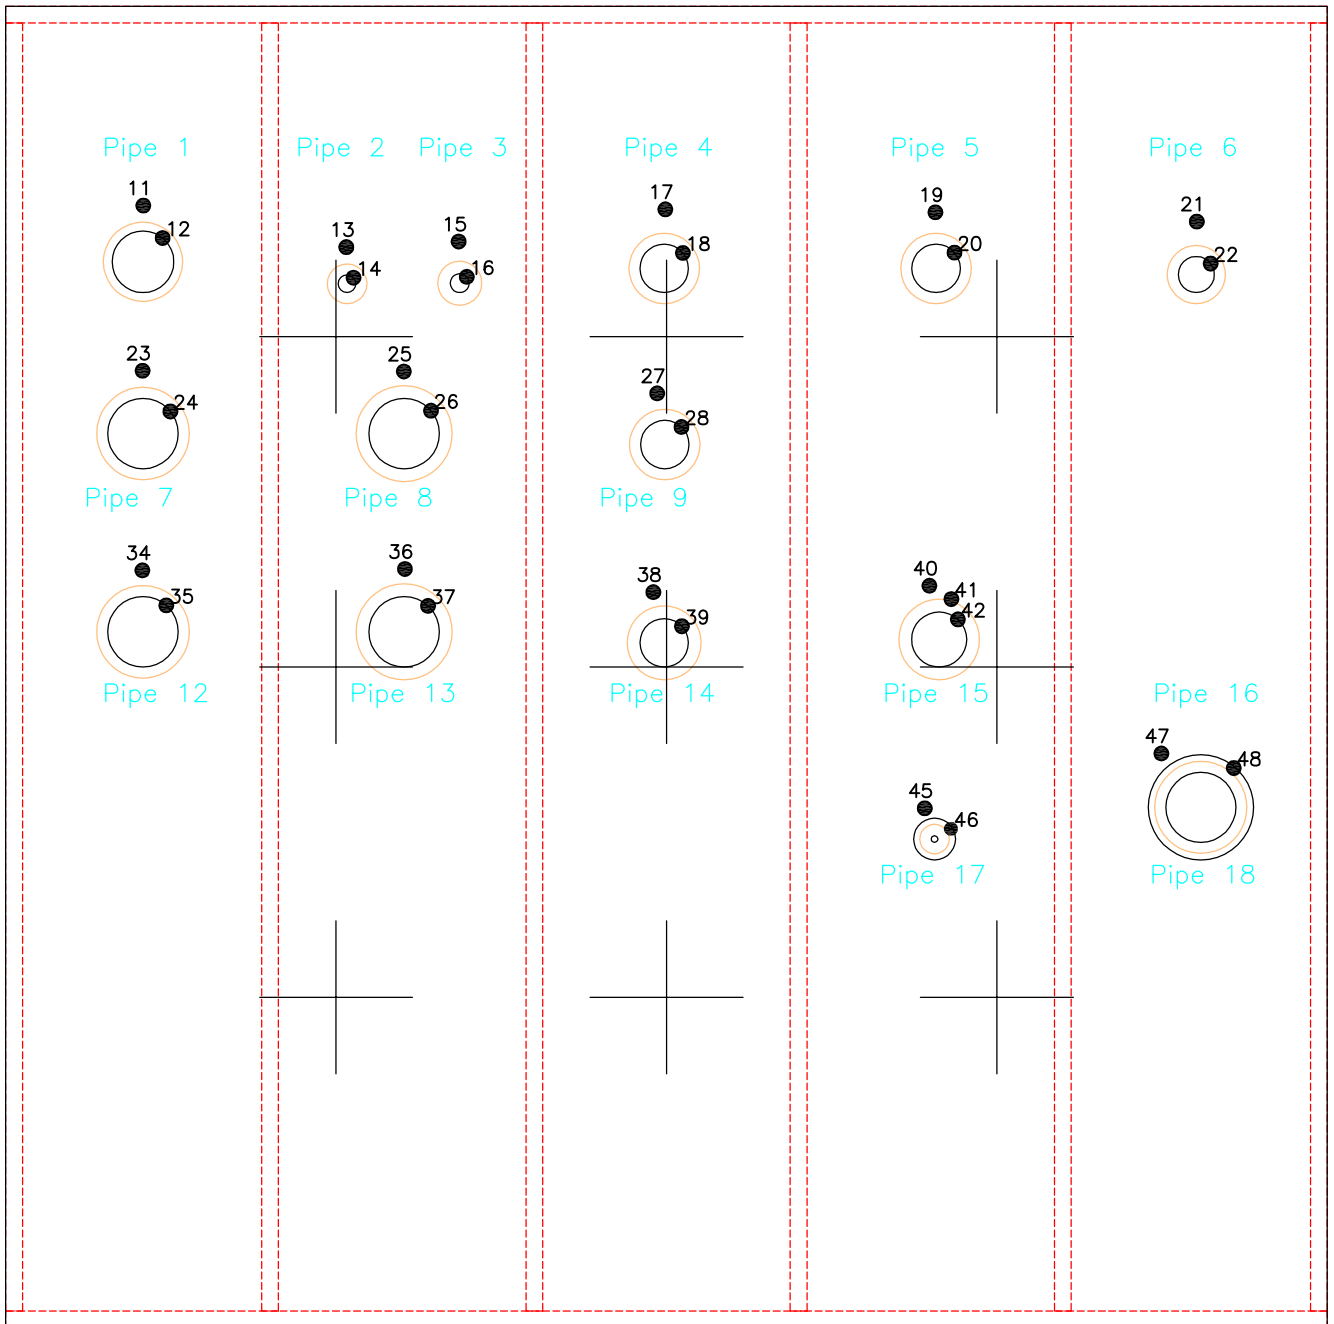
: Furnace Thermocouples

#### 5.4 Thermocouple positions ( see Appendix 1 figure 5)
